TIGERTAIL LAGOON & SAND DOLLAR ISLAND ECOSYSTEM RESTORATION

Engineering Management Plan

Prepared for
City of Marco Island

Prepared by
Humiston & Moore Engineers
md@humistonandmoore.com

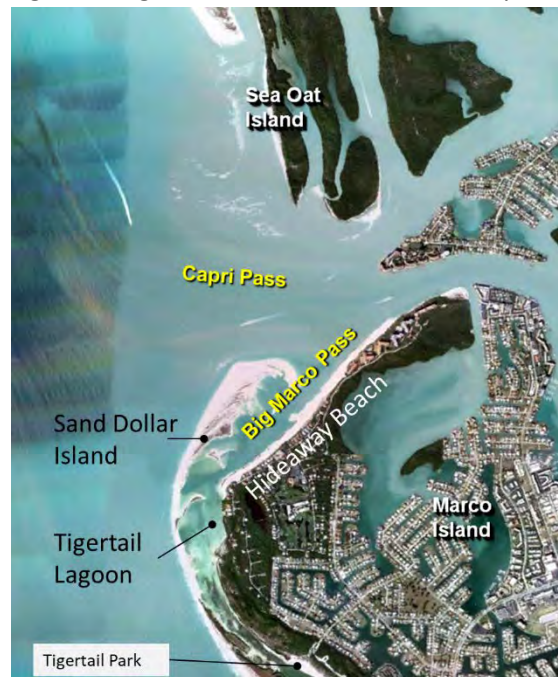
Figure 1: Study area location

Figure 1 shows the location of the study area which extends from the central part of Marco Island's gulf coast to the northwest part of the island. The evolution of Tigertail Lagoon and Sand Dollar Island is part of ongoing large scale natural tidal inlet evolution at the north end of Marco Island. Prior to the 1960's, Big Marco Pass was the main inlet between Marco Island and Sea Oat Island. In 1967 Capri Pass was opened on the up-drift side of Big Marco Pass creating a dual inlet system for few decades until Capri Pass became the main inlet for this system in the early 2000's.

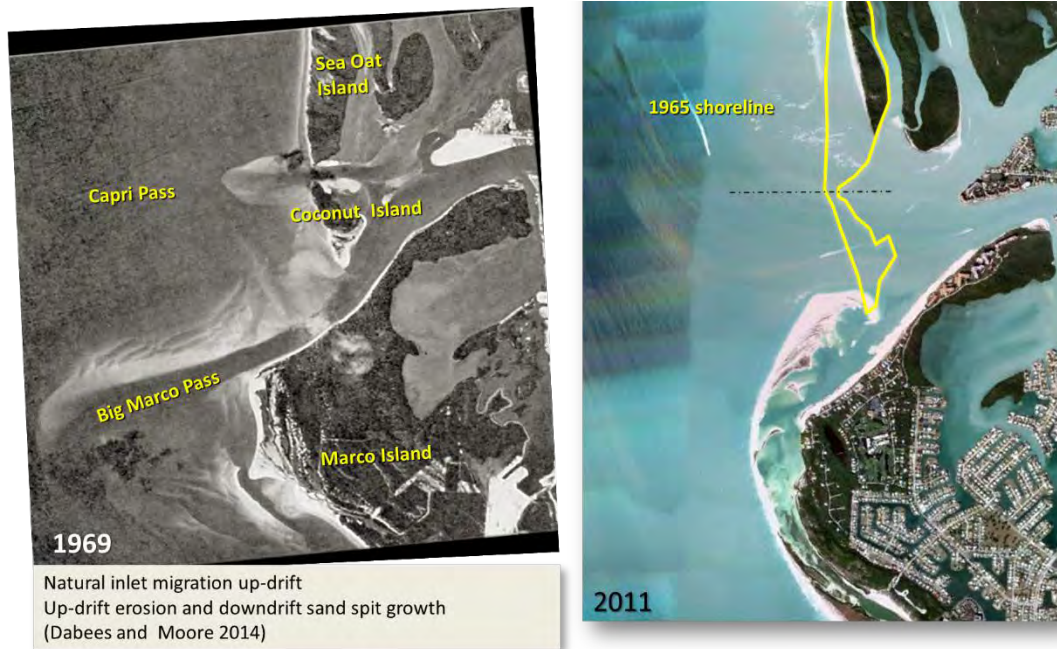
Figure 2: Comparison of the 1960's and existing conditions at the study area

Figure 2 shows the inlet configuration in 1969, two years after Capri Pass was opened, and a comparison of more recent conditions represented by 2011 aerial photos with the 1965 shoreline before Capri Pass opened. The opening of Capri Pass created a dual inlet system of Capri Pass and Big Marco Pass separated by a small island (Coconut Island) and by a large and complex ebb shoal system (Dabees and Kraus, 2004).

process continued until the south inlet closed in the 2000's. Onshore movement of the ebb shoal at the closed inlet provided a large volume of sand to the down-drift beach (Marco Island) and formation of the active ebb shoal to the north. Formation of the new ebb shoal caused significant erosion on the north side of Capri Pass, along the south end of Sea Oat Island. The up-drift beach erosion is represented on the right end side of **Figure 2** which compares the 1965 and existing conditions represented in the figure by the 2011 aerial photo.

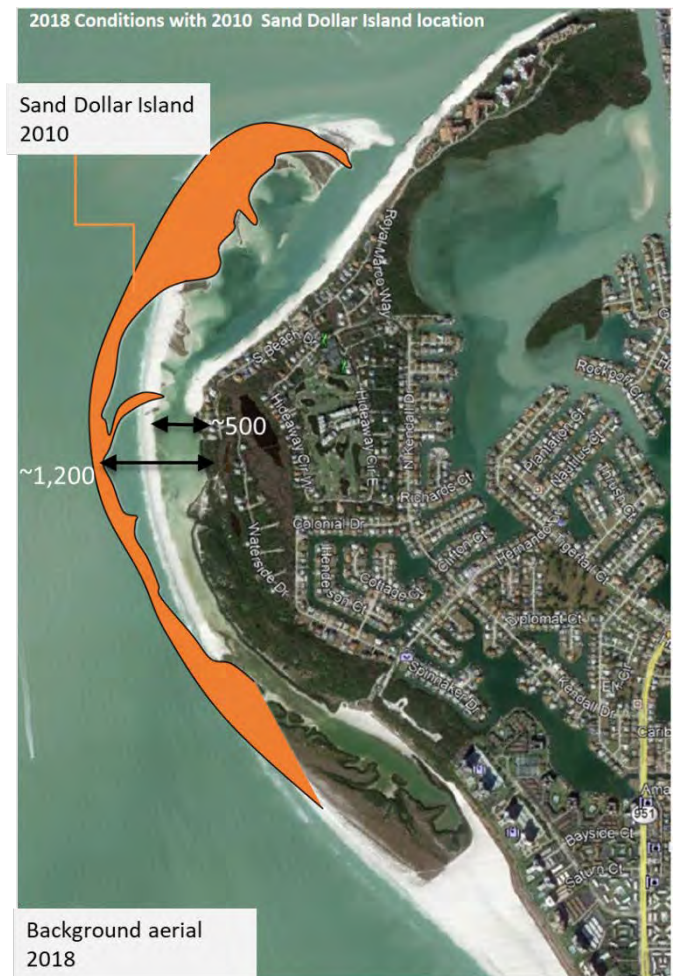
Figure 4: Recent shoreline changes of Sand Dollar Island

Recent morphologic changes from 2010 to present (2021), indicate continued onshore migration of the sand spit along the northwest end of Marco Island. **Figure 4** illustrates the change in the sand spit shoreline from 2010 to 2018.

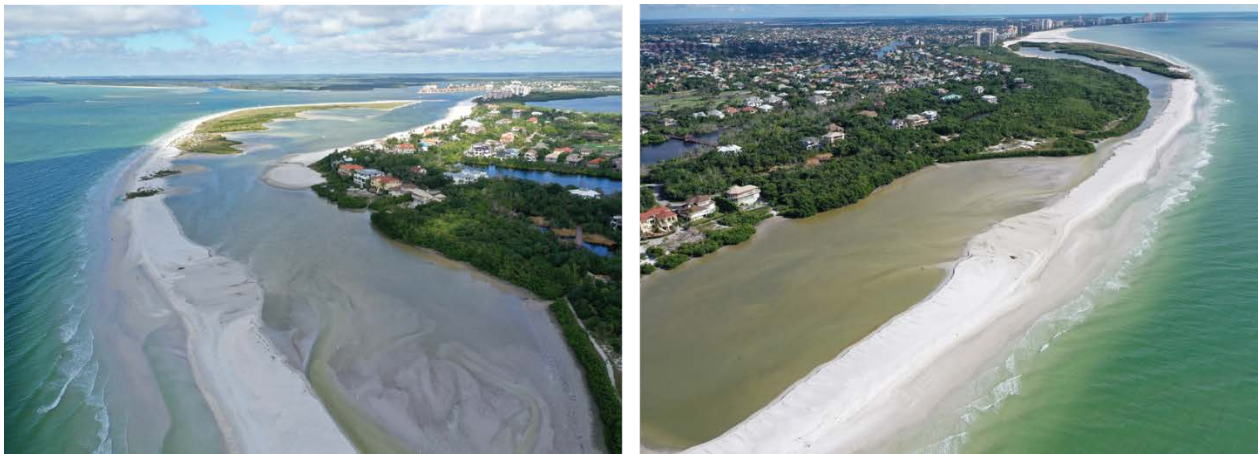
Figure 6: Central Sand Dollar Island beach overwash following tropical storm Eta (November 2020)

Major storms such as Hurricanes Wilma (2005) and Irma (2017) occur at approximately decadal frequency. When they occur, they cause significant morphologic response. In the case of Sand Dollar Island the storms caused lowering of the beach elevations in the middle part of the sand spit leaving it more vulnerable to erosion and overwash during typical storm events that may occur several times a year. For example, over the tropical season of 2020, two tropical storms passed offshore in the Gulf of Mexico, Cristóbal (June 2020) and Eta (November 2020). These two events generated mild storm surge and wave height but caused significant morphologic response at the middle section of Sand Dollar Island due to the low elevation of that section. **Figure 6** shows aerial photos taken post tropical storm Eta, indicating over wash and breaching at the middle section of the sand spit.

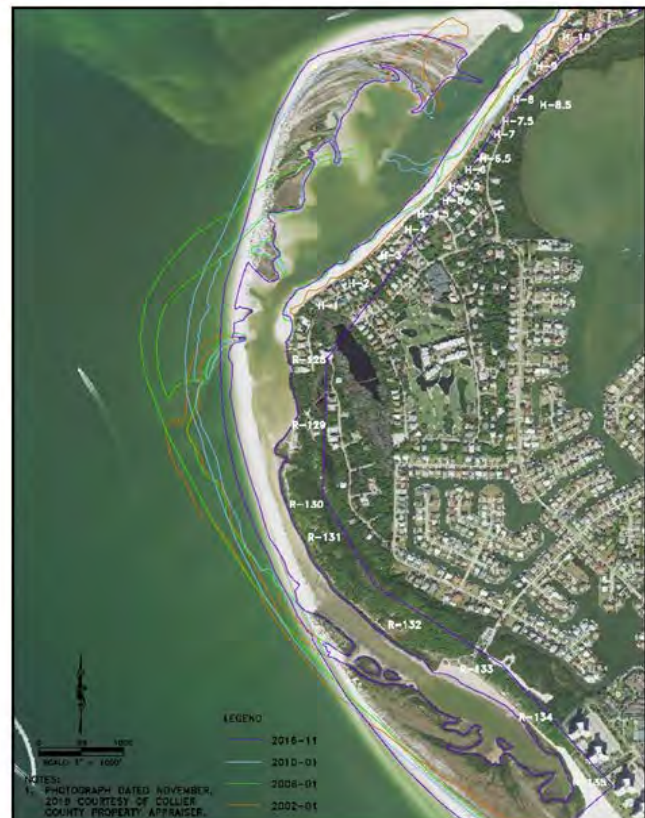
Figure 8: Shoreline changes on Sand Dollar Island

The aerial imagery illustrates the recession of the spit between R-128 and R-131 from near its most seaward location in January 2006 to November 2019. Accompanied by the recession has been growth of a large emergent area to the north of R-128 wrapping into the Big Marco River and accretion south of R-132 over the same time period.

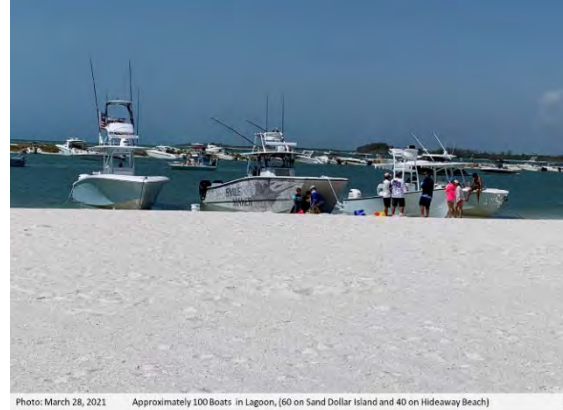
Figure 15: Tigertail Lagoon zone 1

Zone 1 is the area from the north end of the lagoon entrance to DEP reference monument R128. This zone represents relatively deep-water depth greater than 10 feet where the remnant channel of Big Marco Pass existed. A localized small area of seagrass was identified near the north part of zone 1. **Figure 15.** Shows ground photo of zone 1 showing the boating activities on both sides of the lagoon.

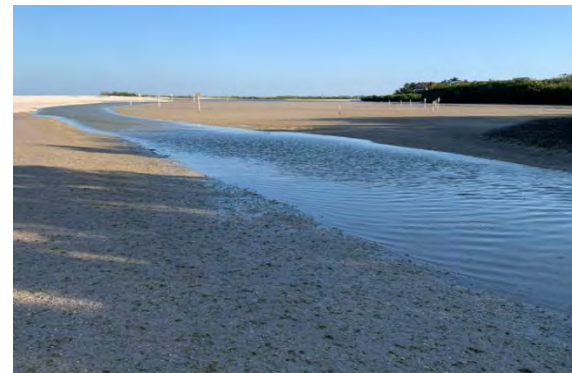
Figure 16: Tigertail Lagoon zone 2 at low tide

Zone 2 represents the lagoon area between DEP R monuments R128 to R130. This area is where significant narrowing and shoaling occurred over the past few years. The water depths are shallow, varying between 1 and 2 feet deep. The submerged resource survey indicates no sea grass beds in this zone in 2018 and a sparse sea grass bed in 2020. **Figure 16** shows a ground view at low tide of zone 2 indicating the shoaling of the lagoon.

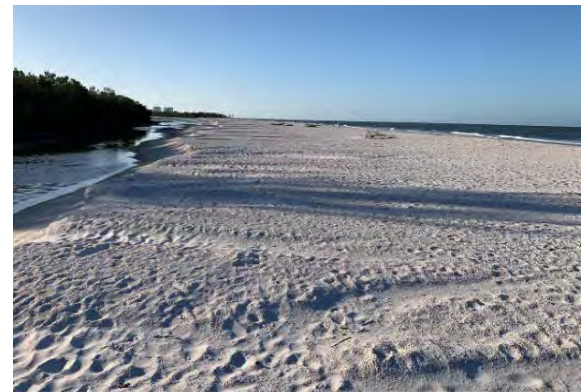
Figure 17: Tigertail Lagoon zone 3 at low tide

Zone 3 represents the lagoon area between DEP R monuments R130 to R133. This area is shallow and very narrow where flow is restricted especially during low tides. The submerged resource survey indicates significant sea grass beds in this section. **Figure 17** shows ground view taken in March 2021 at low tide of zone 3 showing the significant narrowing of zone 3. In this area, the shoaling and overwash continues to cover seagrass beds that existed in years past.

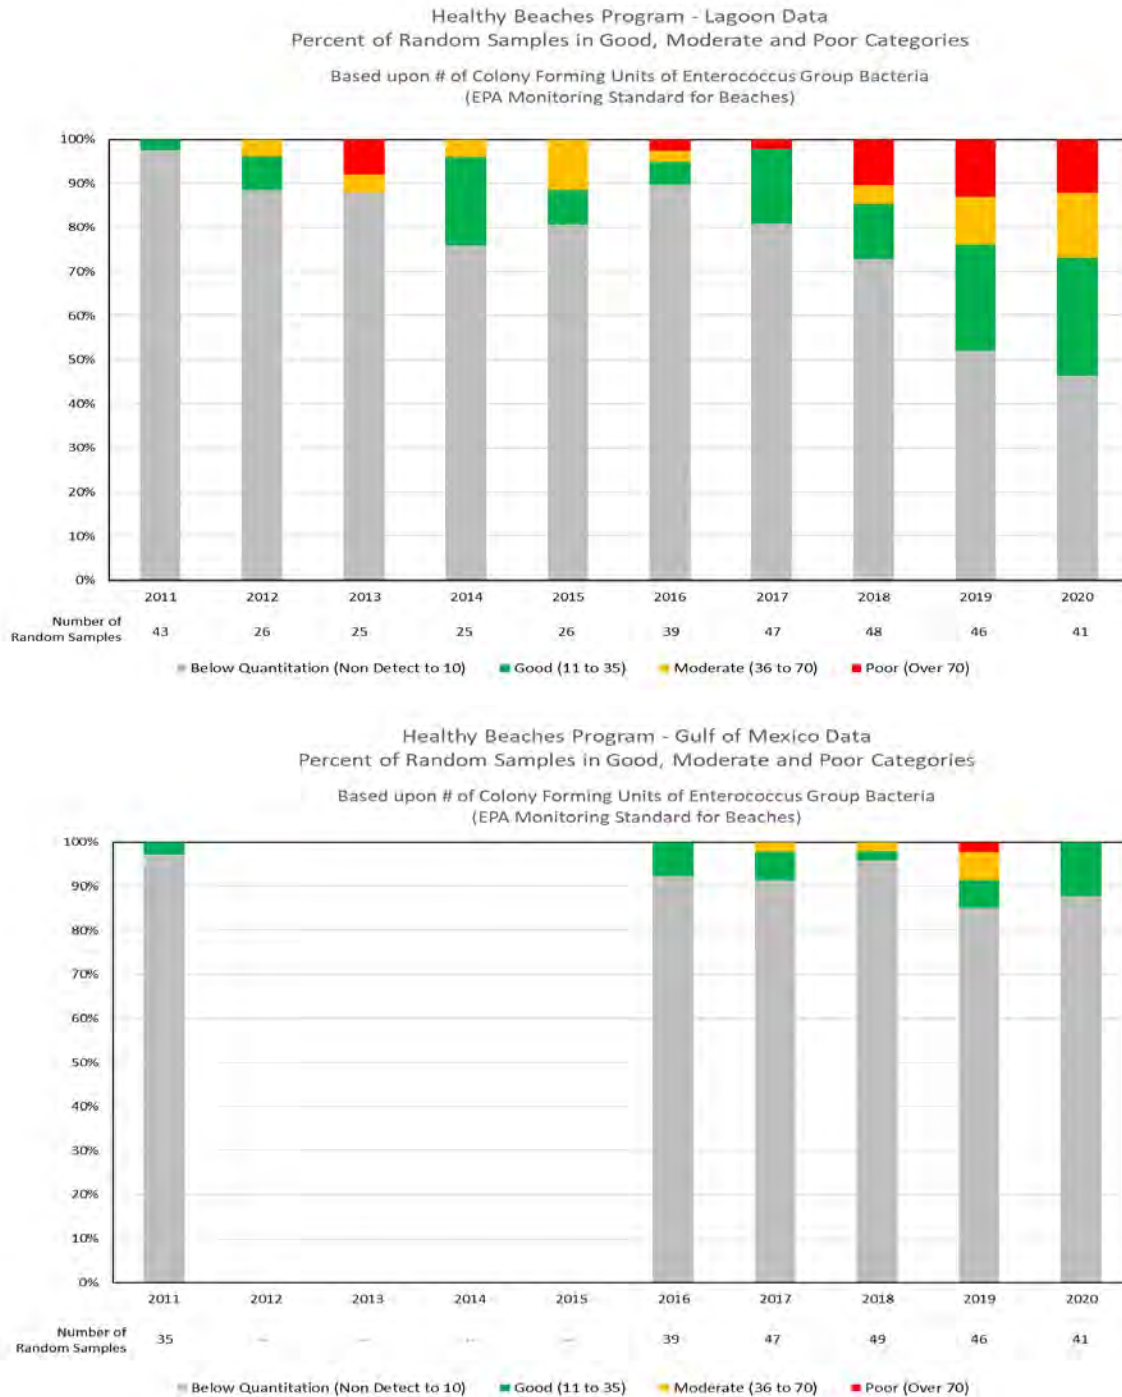
Figure 18: Enterococcus concentrations in Tigertail Lagoon and gulf beach

The Florida Healthy Beaches program conducts water quality monitoring of beaches throughout Florida, including Tigertail Lagoon. Monitoring is conducted for *Enterococcus* bacteria as a surrogate for wastewater to identify potential impacts to human health as recommended by the US EPA. *Enterococcus* lives in the digestive tract of mammals and birds. It is a naturally occurring bacteria found in fresh and marine waterbodies. Random samples are collected, and if elevated levels are detected, a second sample is collected to confirm that conditions have returned to safe levels. If elevated levels continue, beach warnings or closures may be implemented.

This analysis is not intended to identify the source of the bacteria or determine the causes of the increase. However, the trend is consistent with reduced flushing of the lagoon, particularly in recent years after Hurricane Irma, 2018, 2019, and 2020. The data illustrate a system that would benefit from improved flushing.

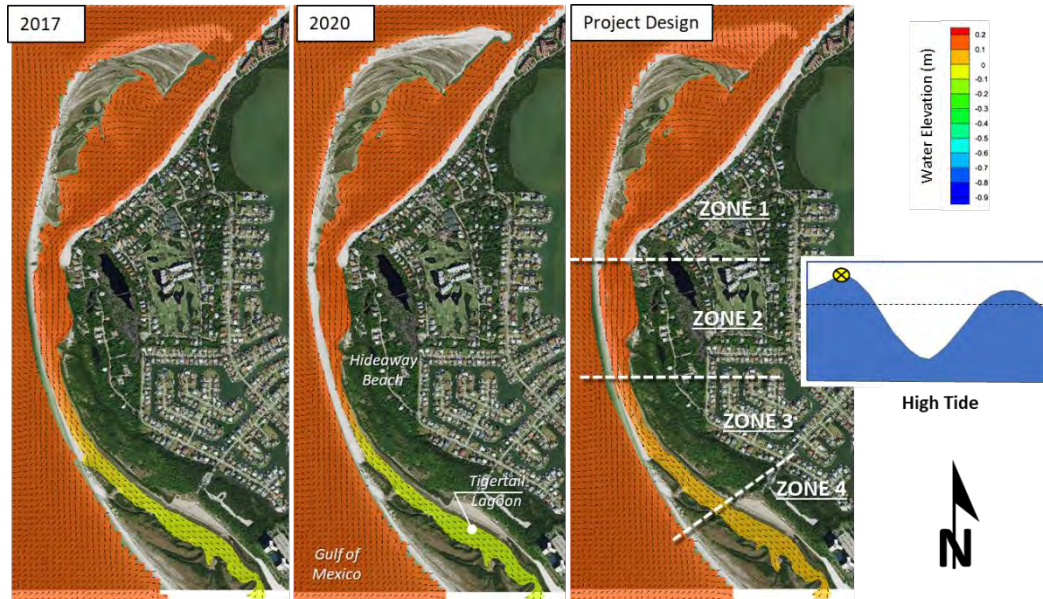
Figure 24: CMS model results -Water levels at high tide

The results from the simulations are presented in **Figures 24 to 26**. **Figure 24** presents a sample model result for one timestep during high tide. The results indicate that at high tide, the water levels in the lagoon are lower than in the Gulf of Mexico for the 2017 & 2020 conditions. With the proposed improvements to the system, the lagoon water levels would be slightly higher indicating a more efficient system. **Figure 25** presents the same simulation results during low tide. The model shows that at low tide, conditions have deteriorated between 2017 and 2020, and in 2020 the lagoon becomes completely disconnected from the Gulf of Mexico at low tide. The project design improves flushing of the lagoon to levels similar to that of 2017.

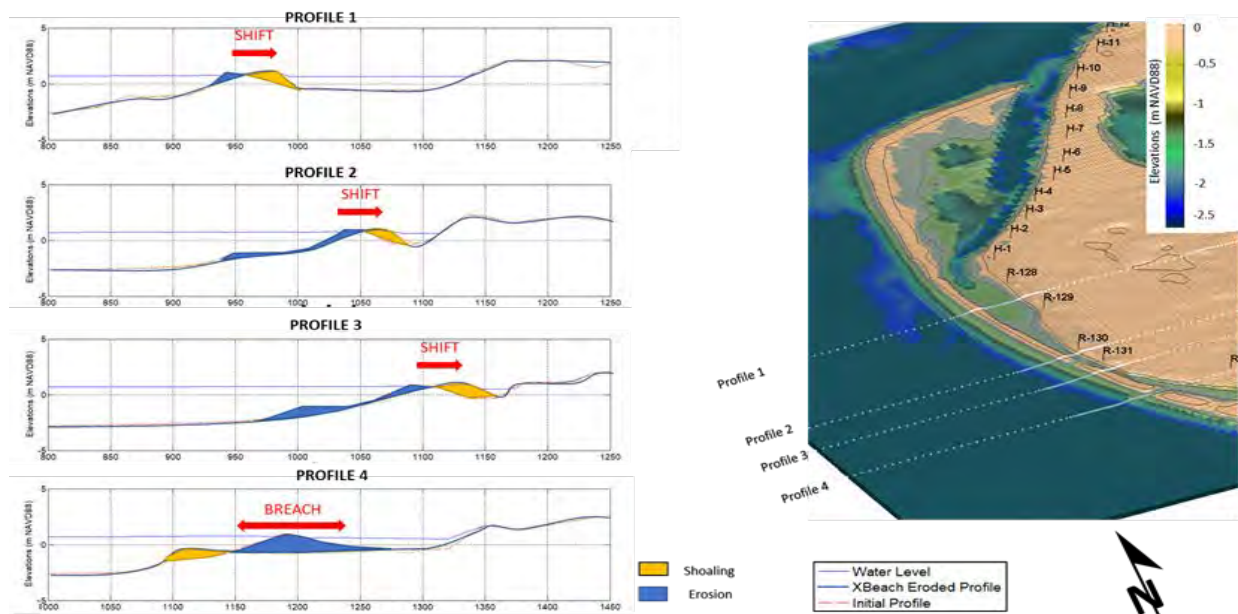
Figure 30: XBeach Profile Change Results – Storm Eta – Existing Conditions

Figure 30 presents the same model results extracted at 4 profiles along Tigertail. For each profile, the initial conditions are shown as a dashed line and the final profile is indicated in blue with areas of erosion and shoaling shaded in blue and orange respectively. Profiles 1 through 3 show a landward shift of the berm, shoreline recession, and narrowing of the channel. Profile 4 falls in one of the areas which experienced breaching during the simulated storm, therefore the eroded profile is flat because the berm completely eroded.

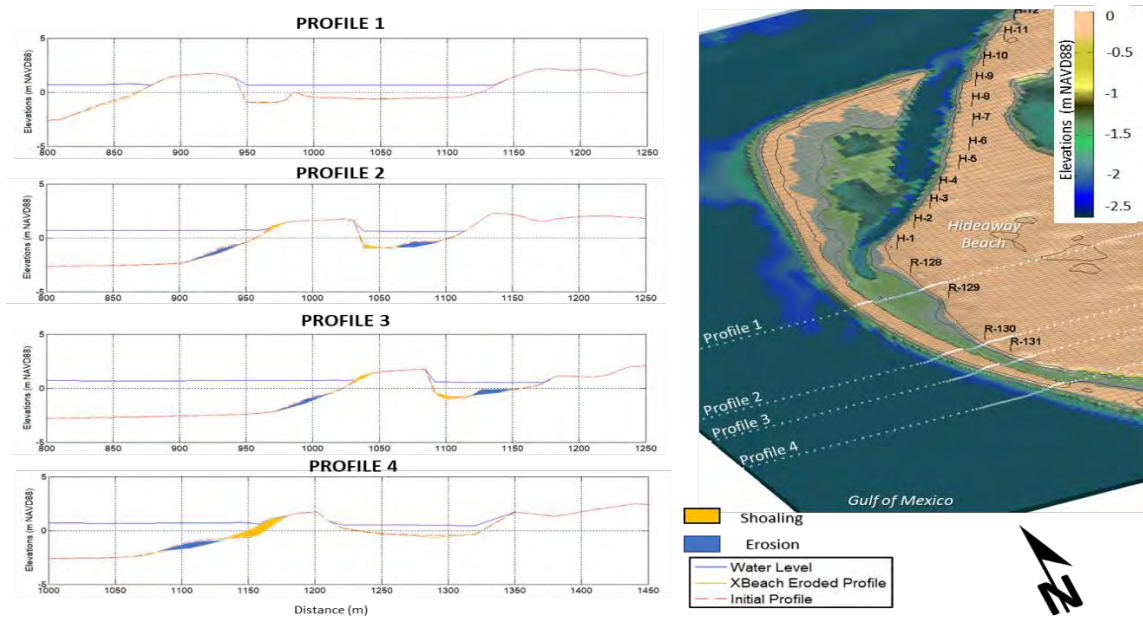
Figure 32: XBeach Model Results – Storm Eta –Design Conditions

Figure 32 shows the model results for the enhanced berm for the same 4 profiles along Sand Dollar Island that were presented for existing conditions in Figure 28. The cross sections show typical profile adjustment on the shore face without overwash or shoaling in the lagoon. The model also indicated the model berm function in separating the lagoon water from the open gulf for that level storm. This functioning of the beach berm and enhanced profile effectively reduces shoaling with the lagoon from overwash and minimizes potential for suspended sediment settling in the lagoon under high frequency storms.

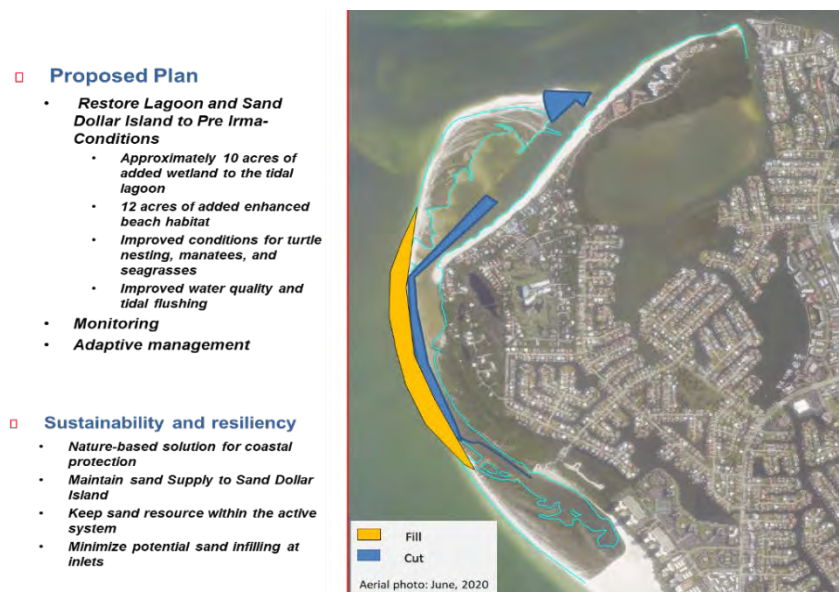
The proposed plan would restore the Sand Dollar Island to its 2016 Mean High Water position, provide enhanced resiliency of the spit, and create an enhanced tidal circulation channel within Tigertail Lagoon. This is accomplished by connecting the existing nearshore borrow area at Hideaway Beach with the sand trap and creating a flow channel along the back of Sand Dollar Island to provide enhanced flushing to the southern lagoon area. A general sketch and highlights of the proposed plan are shown in **Figure 34**.

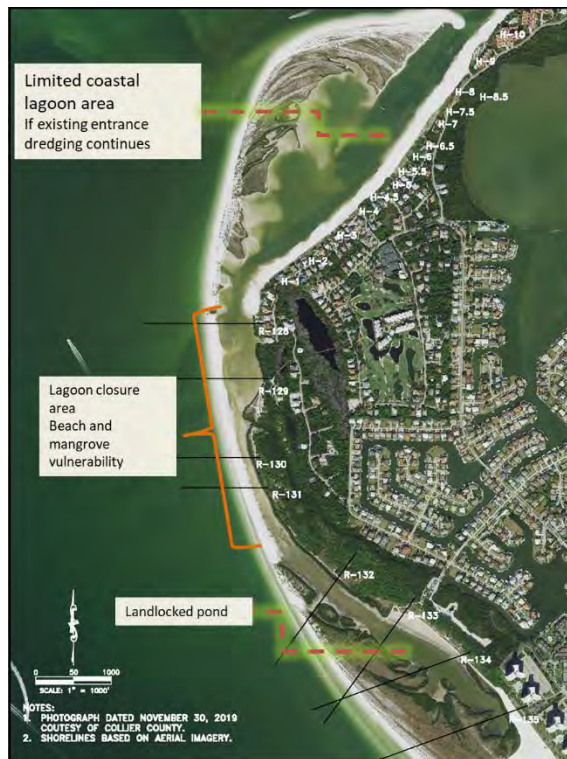
□ No action

- **Closure of central part of the lagoon**
 - Loss of wetland habitat and seagrasses
 - Coastal erosion and vulnerability to mangrove areas
- **Landlocked pond at Tigertail lagoon**
 - Water quality problem
 - Loss of coastal lagoon environment
- **Limited northern coastal lagoon if entrance dredging continues**
- **Increased entrance dredging frequency/costs**
- **Continued spit growth to northeast and increased sand flow into navigation channels**
- **Likely complete lagoon closure**

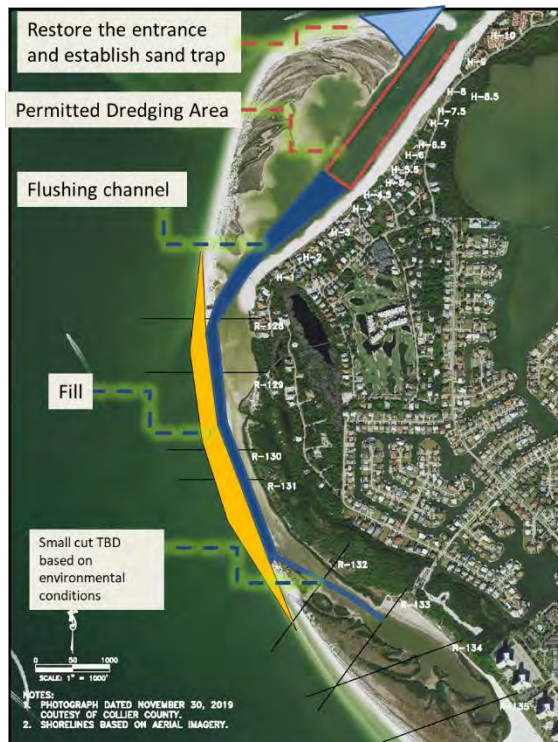
□ Recommended Plan

- **Maintain lagoon area as wet estuary**
- **Address shoaling in the lagoon through initial dredging and future maintenance dredging with consideration to seagrasses**
- **Restore Tigertail Lagoon and Sand Dollar Island to Pre Irma (2017 conditions)**
- **Restore and enhance Sand Dollar Island for coastal resiliency and for bird and turtle nesting habitat**
- **Restore tidal circulation channel on backside of Sand Dollar Island to improve lagoon flushing**

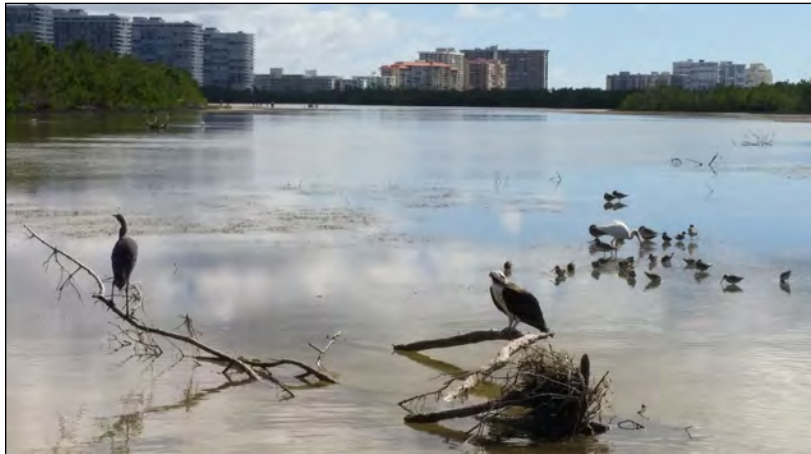
Figure 6 – Typical view of Area 2 (2021).

Area 2, north of Area 3, is the primary subject of this restoration project. It has also been described as the “pinch point” for the system due to a significantly narrower barrier island geography and the shallowest aquatic section of the entire system. Where a western dune once existed, it has been beaten down by several storm systems and lowered to the point where it is now over washed even during moderate storms. This area is being pushed toward the mainland at an average rate of approximately 40 to 50 feet per year, overtaking/burying existing mudflats and seagrass mudflats which have been identified as critical foraging areas for the various shorebirds which rest on the island during migratory flights and nesting shorebirds. It is expected that within the next twelve months, barring any severe storm events in 2021, this portion of the system will finally attach to the mainland mangroves, thus severing the flow between the mouth of the system and Tigertail lagoon and eliminating this critical foraging habitat area.

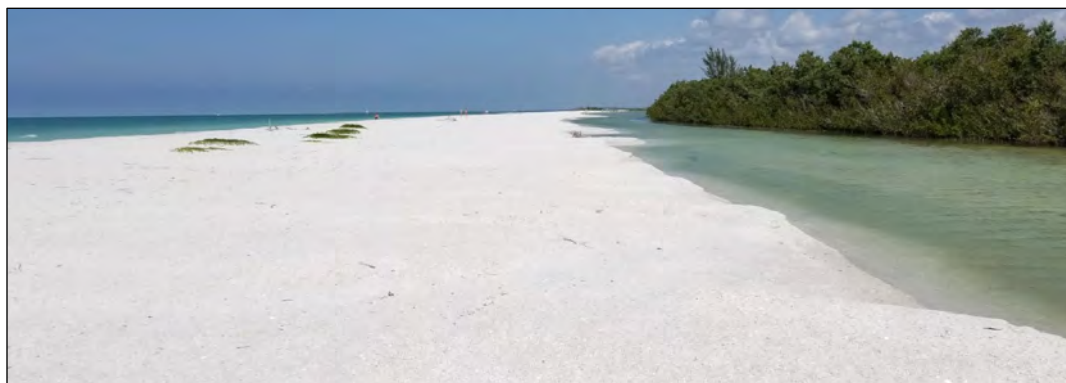
Figure 7 – Northern-most sand spit of Area 1.

habitats which do shift to a lesser degree over time. The most dynamic portion of the system other than Area 2 is the sand spit at the mouth of Marco Pass which is continually affected by tides and currents where it is situated. This area is maintenance dredged and reshaped every two to three years under permits described above.

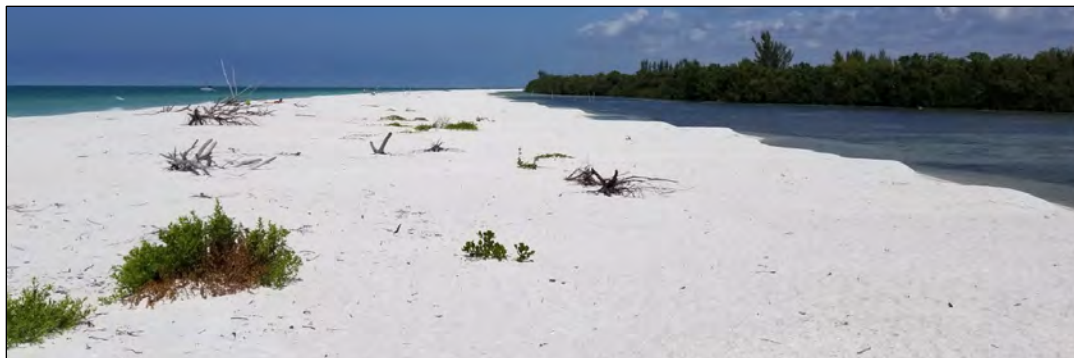
Figure 9 – Dune vegetation west of Tigertail Lagoon.

There is a wide range of coastal vegetation found on site, which includes tree species and groundcover. A list of the observed species can be found below in Table 2. Most of the plant species identified were present in all of the areas surveyed, but their size and dominance varied considerably. In some instances, the beach foredune was dominated by forbs and grasses while in other cases it was dominated by mid and ground-level shrubs (Figure 7). Black mangrove (*Avicennia germinans*) was a prevalent shrub even in foredune habitats varying from six feet in height to ten inches which is indicative of the elevation issues existing on-island. Mangrove species or buttonwood consistently were the lagoon shoreline species, with saltwort (*Batis maritima*) and mangrove seedlings occupying the understory.

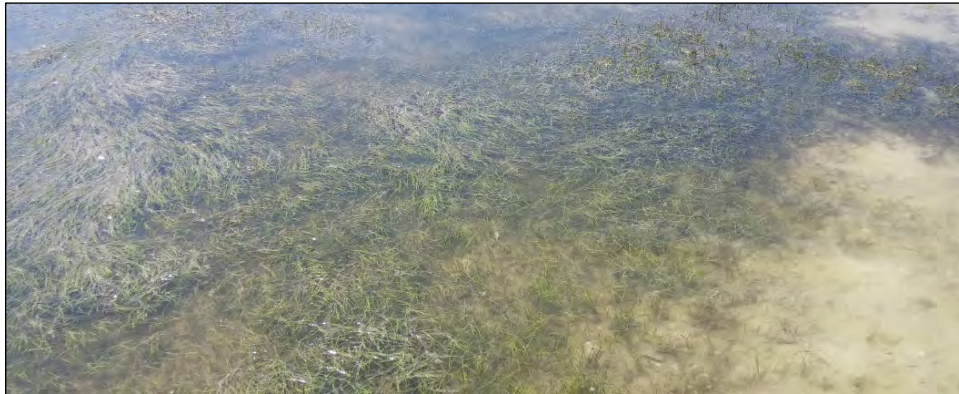
Figure 12 – Typical sparse seagrass bed.

Most of the seagrass patches identified during the 2017, 2018, and 2020 Seagrass Surveys consisted of shoal grass (*Halodule wrightii*), however some paddle grass (*Halophila decipiens*) was also located on the northern end of the survey area (Area 1) in smaller amounts, as were several species of *Caulerpa*. Because the seagrass beds reticulate to such a degree within the system the seagrass was quantified in areas with a range that described the low and high ends of coverage. More detailed discussions can be found in the 2017, 2018 and 2020 Seagrass Survey Reports (Appendices I, II, and III).

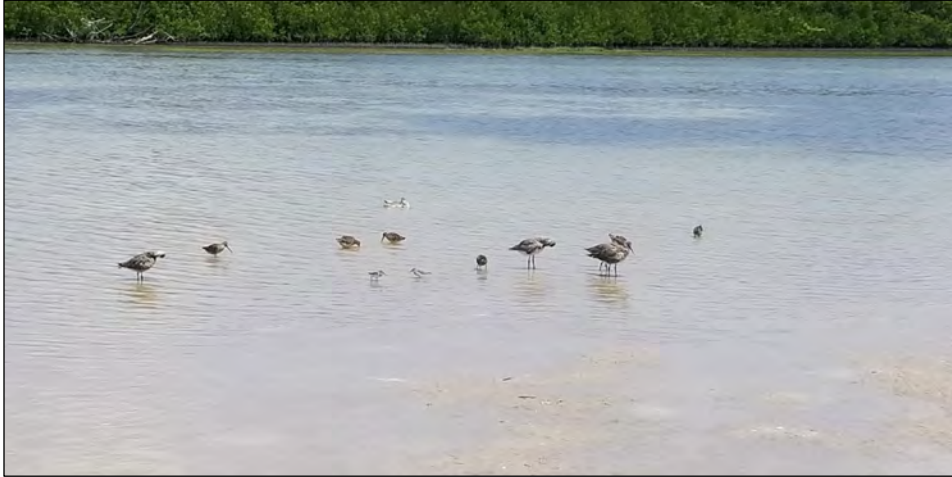
Open water includes all areas that did not contain seagrass beds and are not exposed during low tides. Depths could vary from 12 inches to over 10 feet. Substrate varied by area and could be classified as soft sand, coarse sand, sand with shell debris, and shell debris.

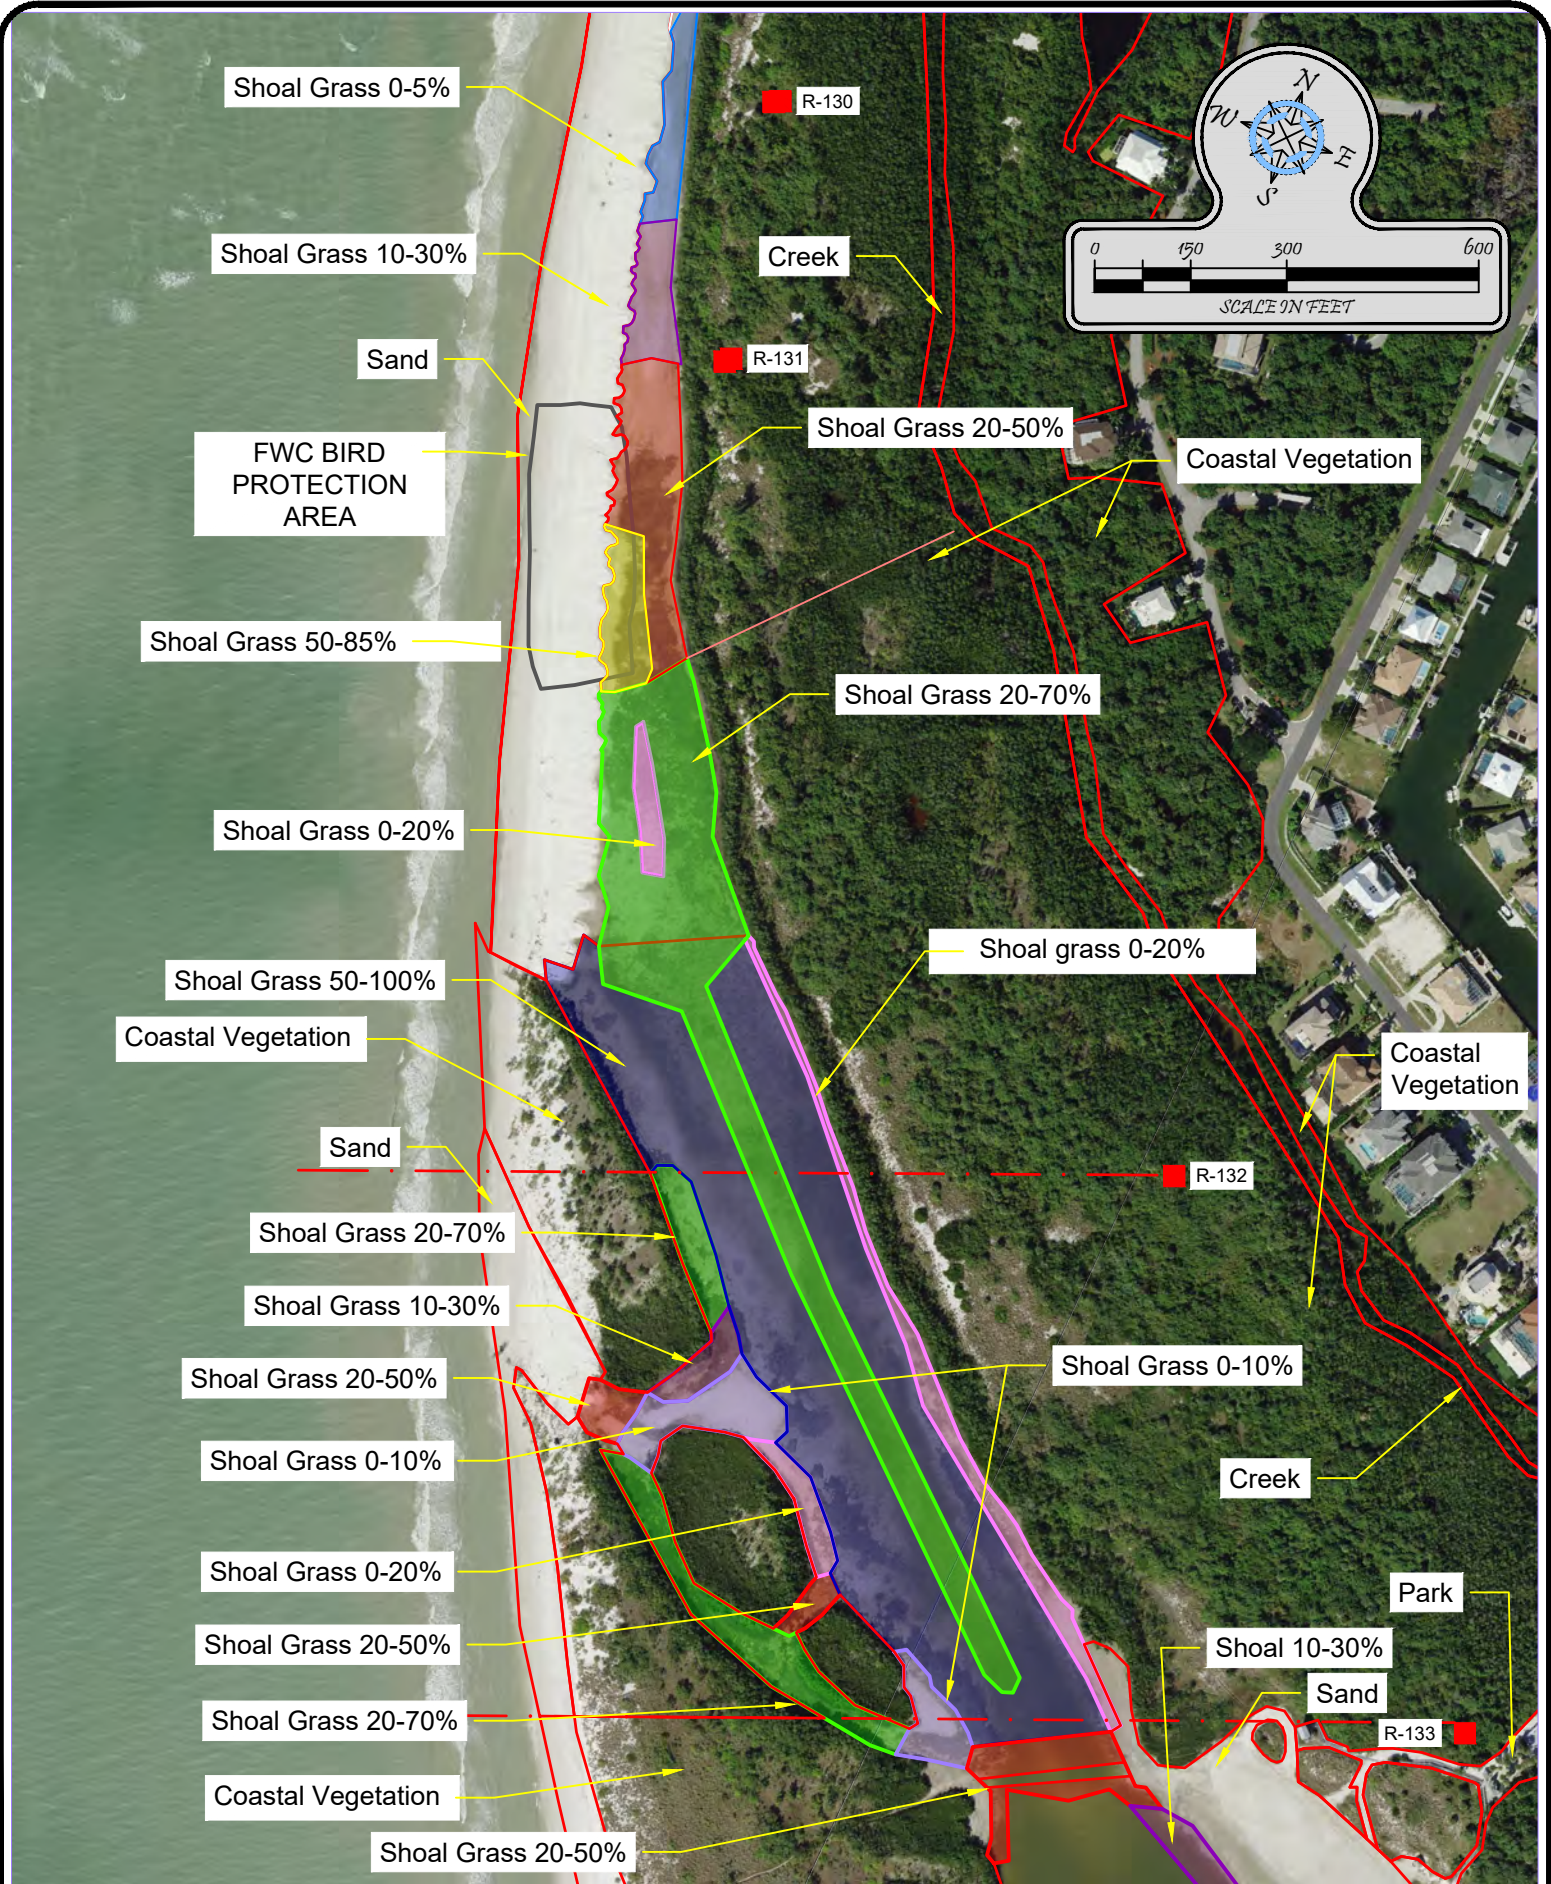
EXHIBIT 6

RESOURCE AREA 3

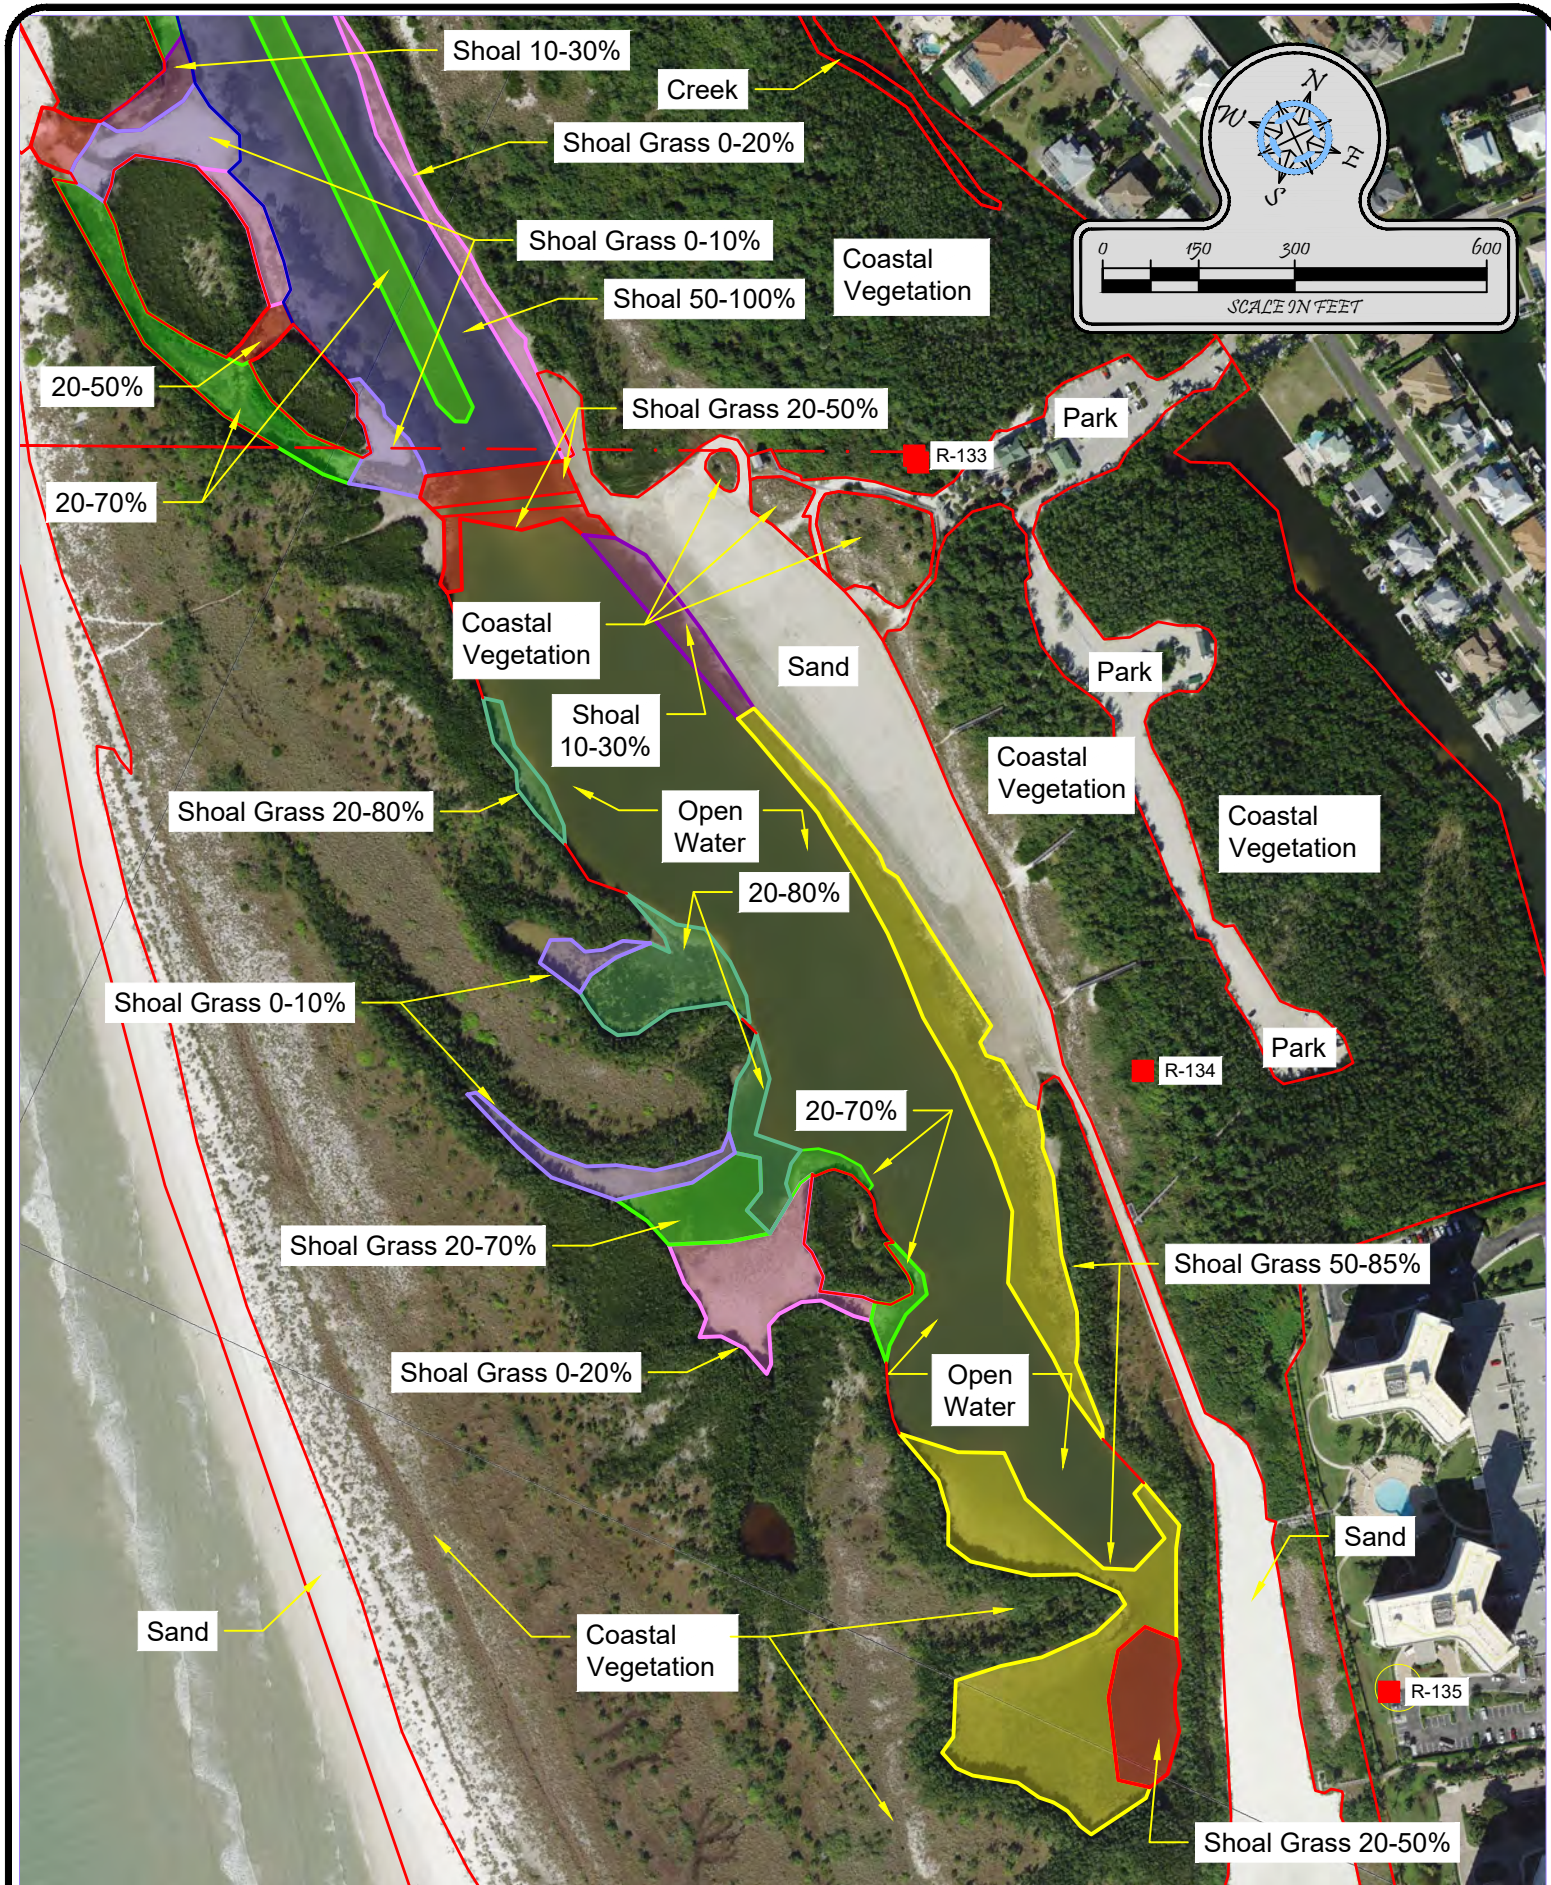
EXHIBIT 7

RESOURCE AREA 4

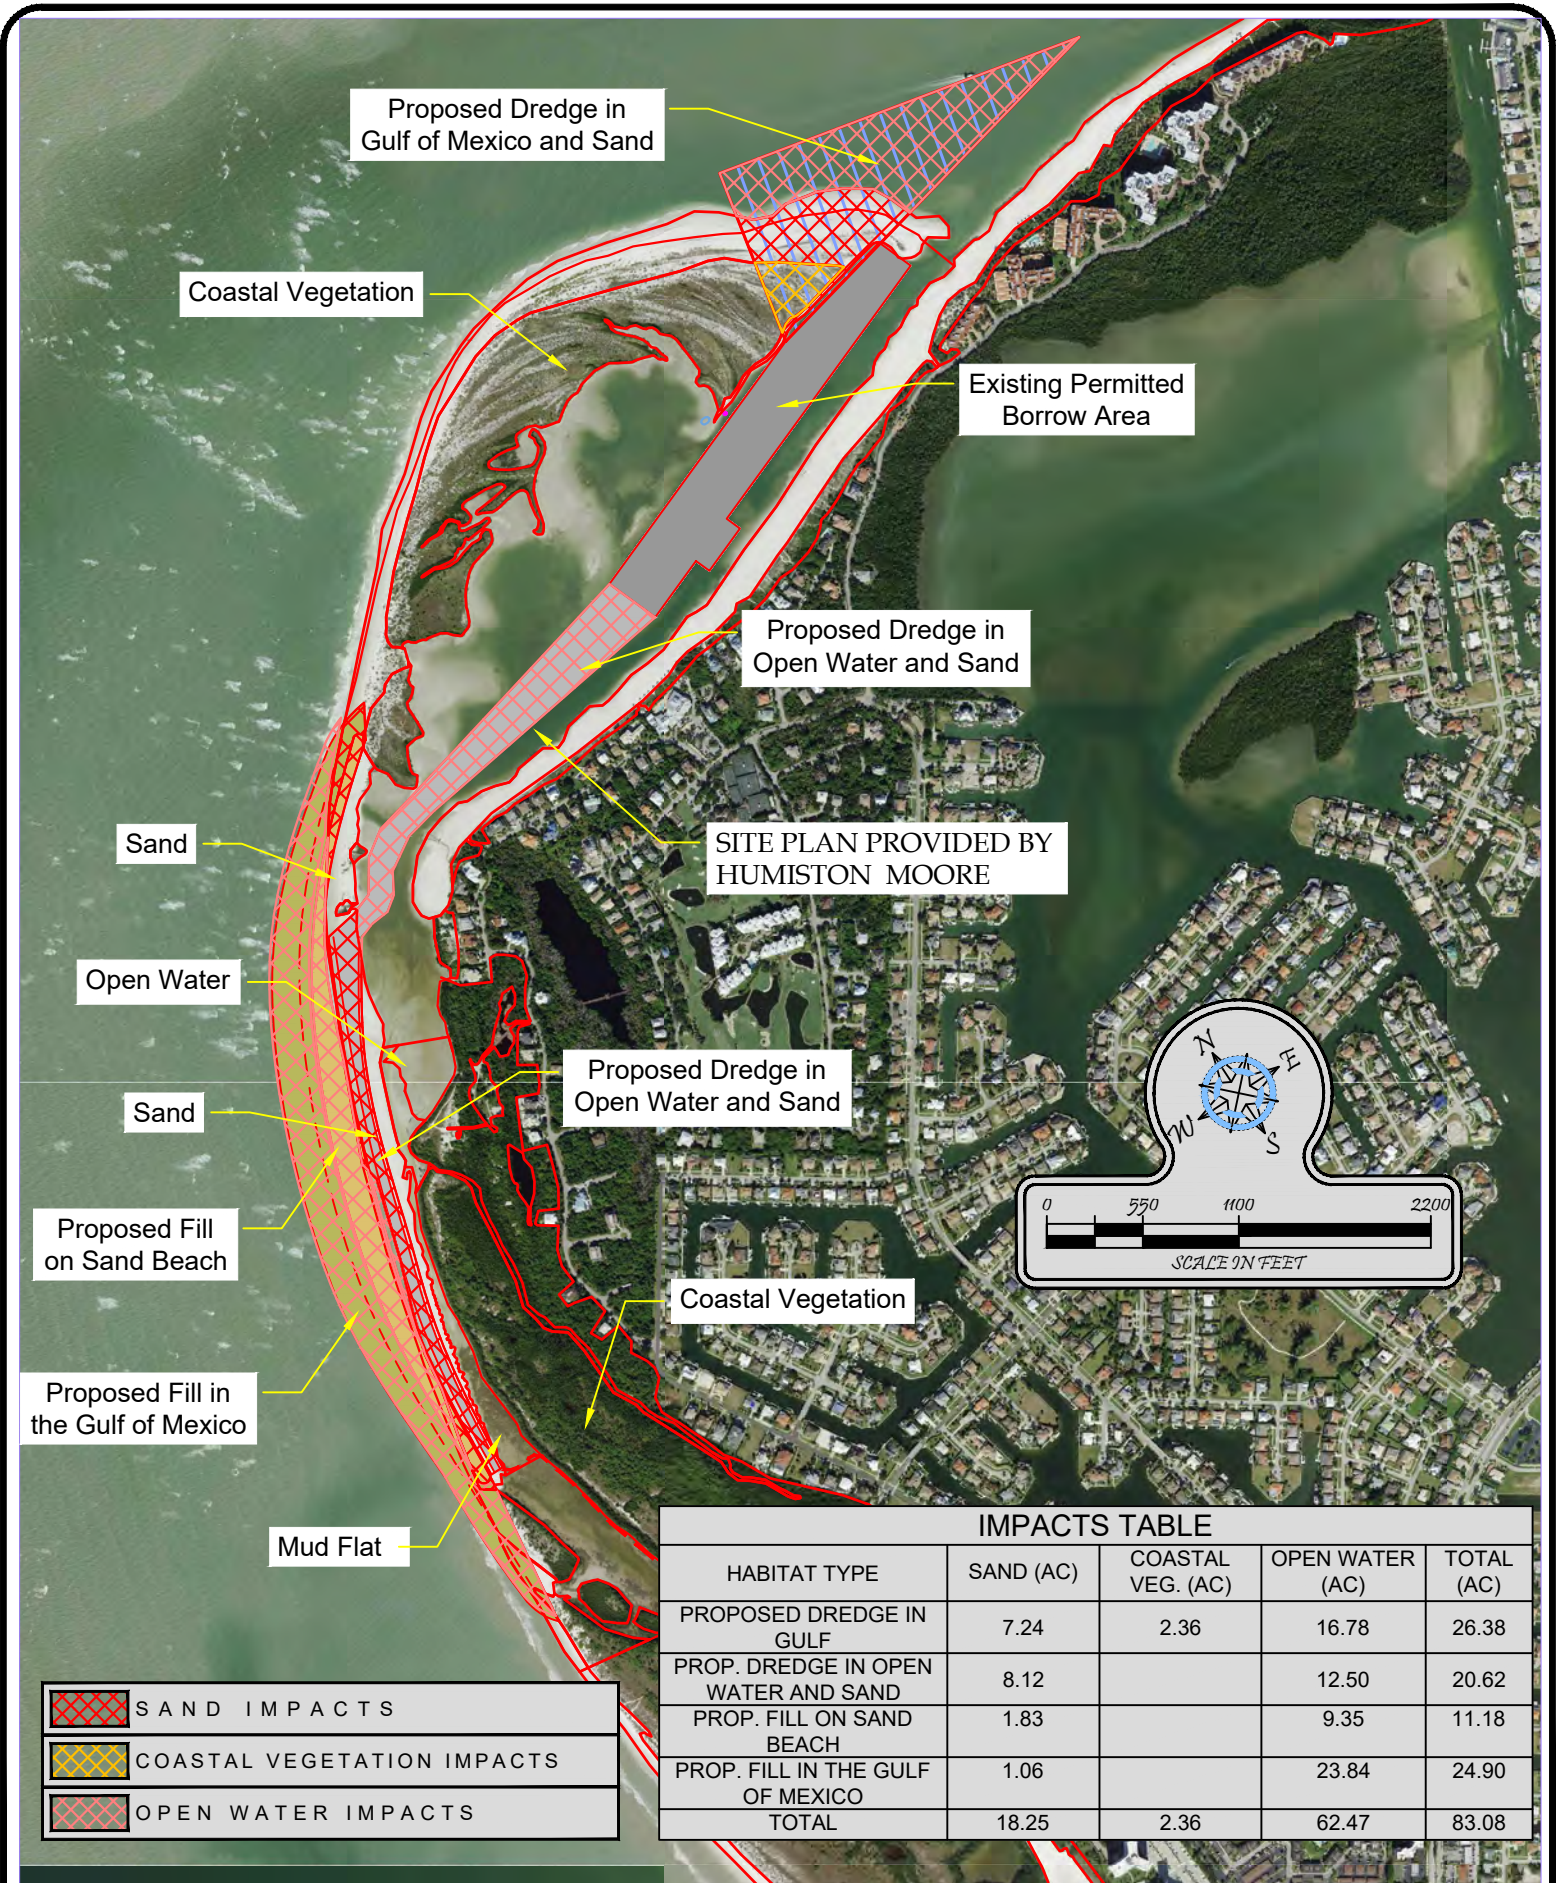
EXHIBIT 9

IMPACTS MAP

IMPACTS TABLE				
HABITAT TYPE	SAND (AC)	COASTAL VEG. (AC)	OPEN WATER (AC)	TOTAL (AC)
PROPOSED DREDGE IN GULF	7.24	2.36	16.78	26.38
PROP. DREDGE IN OPEN WATER AND SAND	8.12		12.50	20.62
PROP. FILL ON SAND BEACH	1.83		9.35	11.18
PROP. FILL IN THE GULF OF MEXICO	1.06		23.84	24.90
TOTAL	18.25	2.36	62.47	83.08
