TIGERTAIL LAGOON & SAND DOLLAR ISLAND ECOSYSTEM RESTORATION

Engineering Management Plan

Prepared for
City of Marco Island

Prepared by
Humiston & Moore Engineers
md@humistonandmoore.com

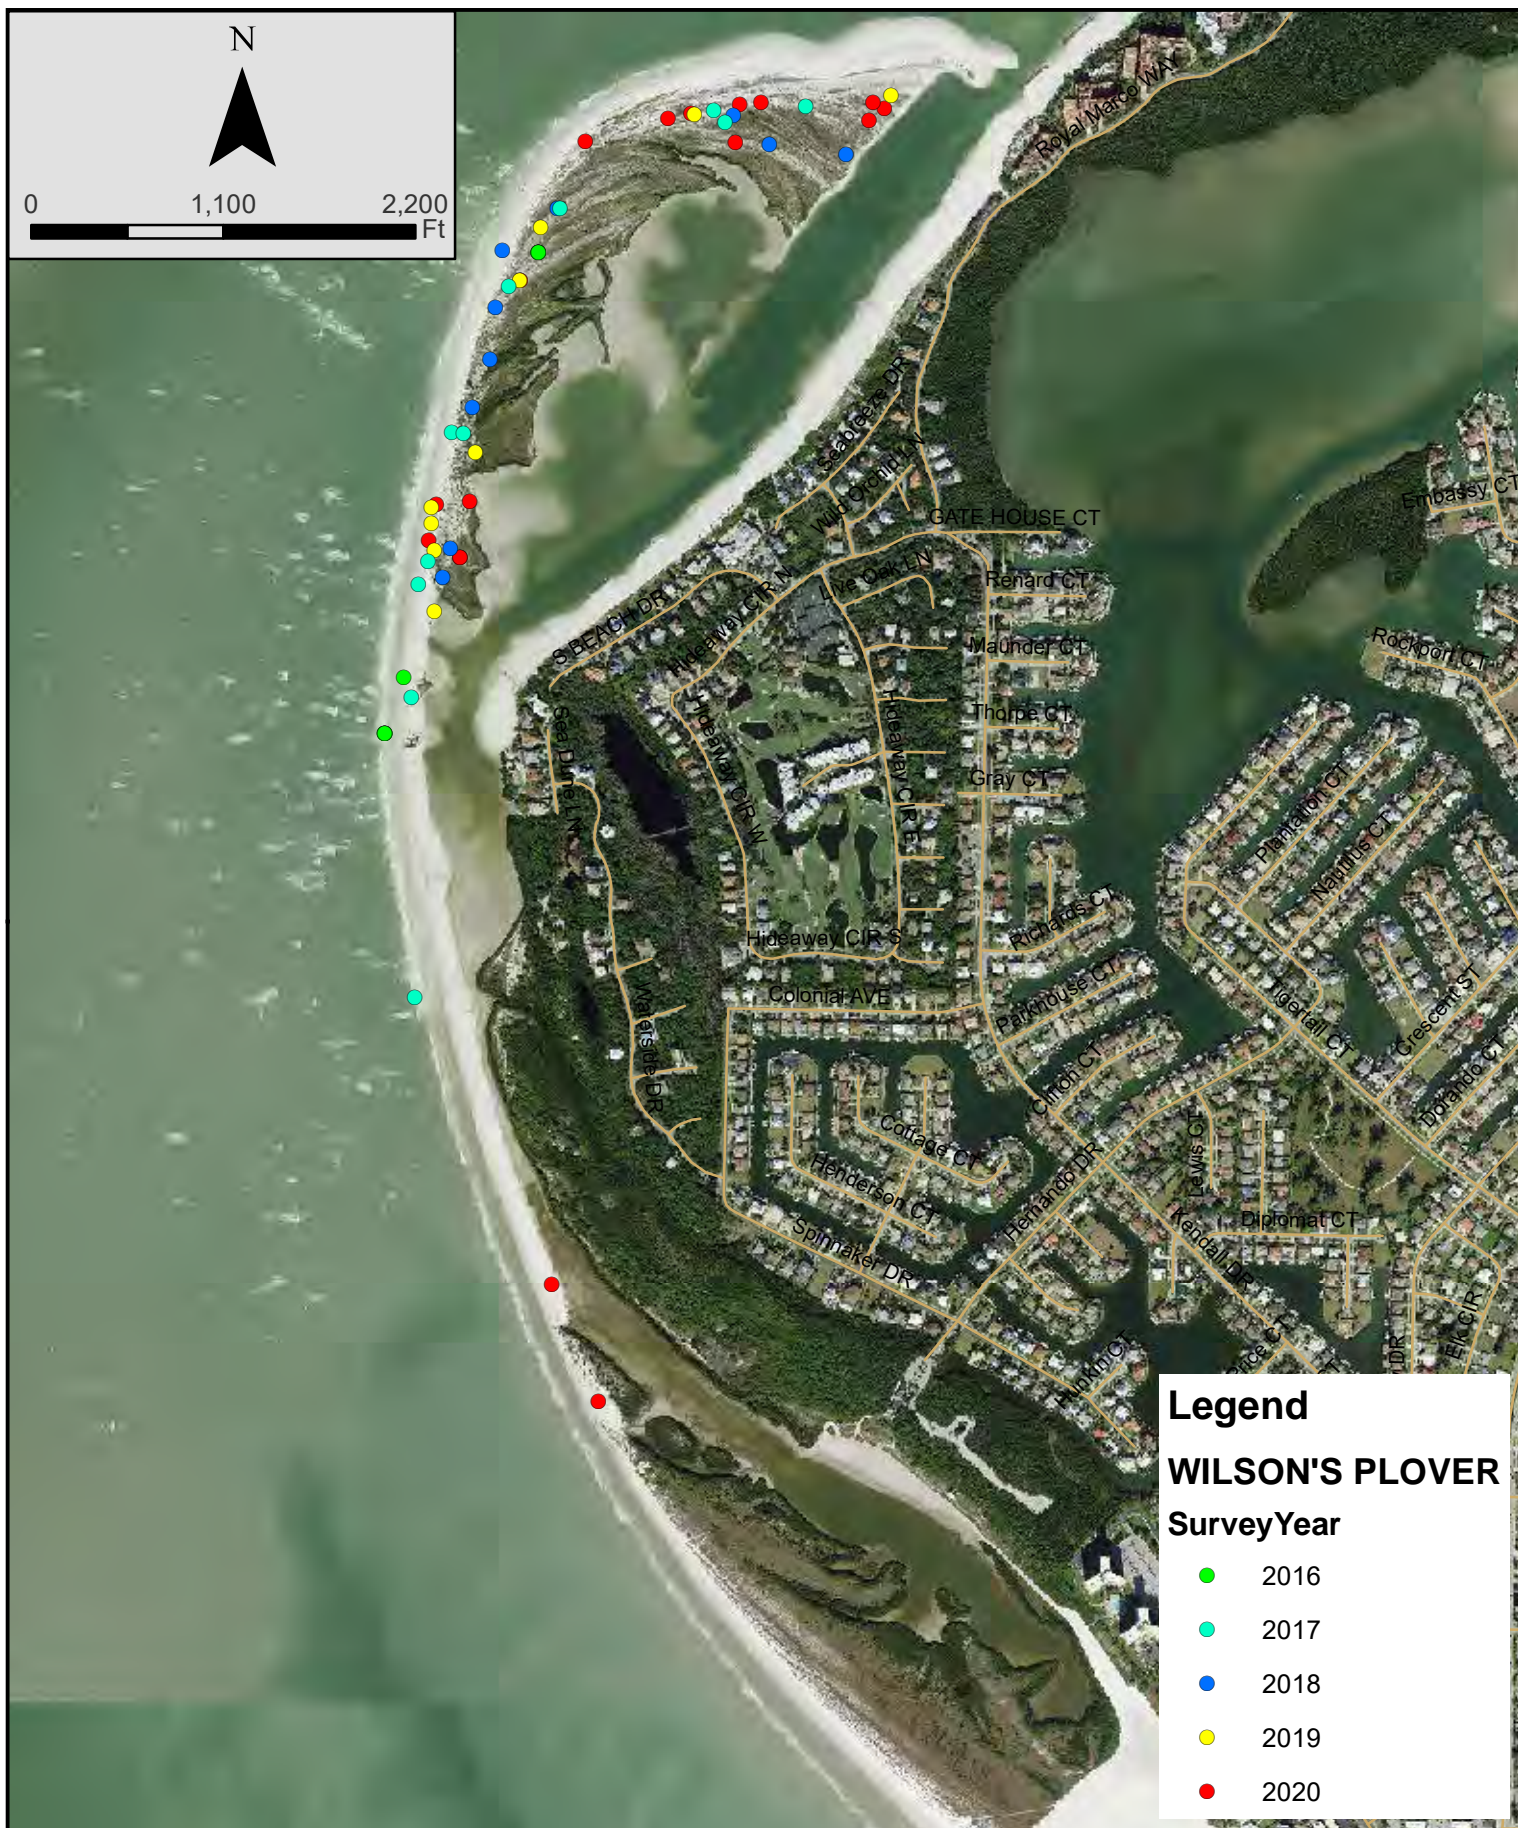
EXHIBIT 10

WILSON'S PLOVER NESTS

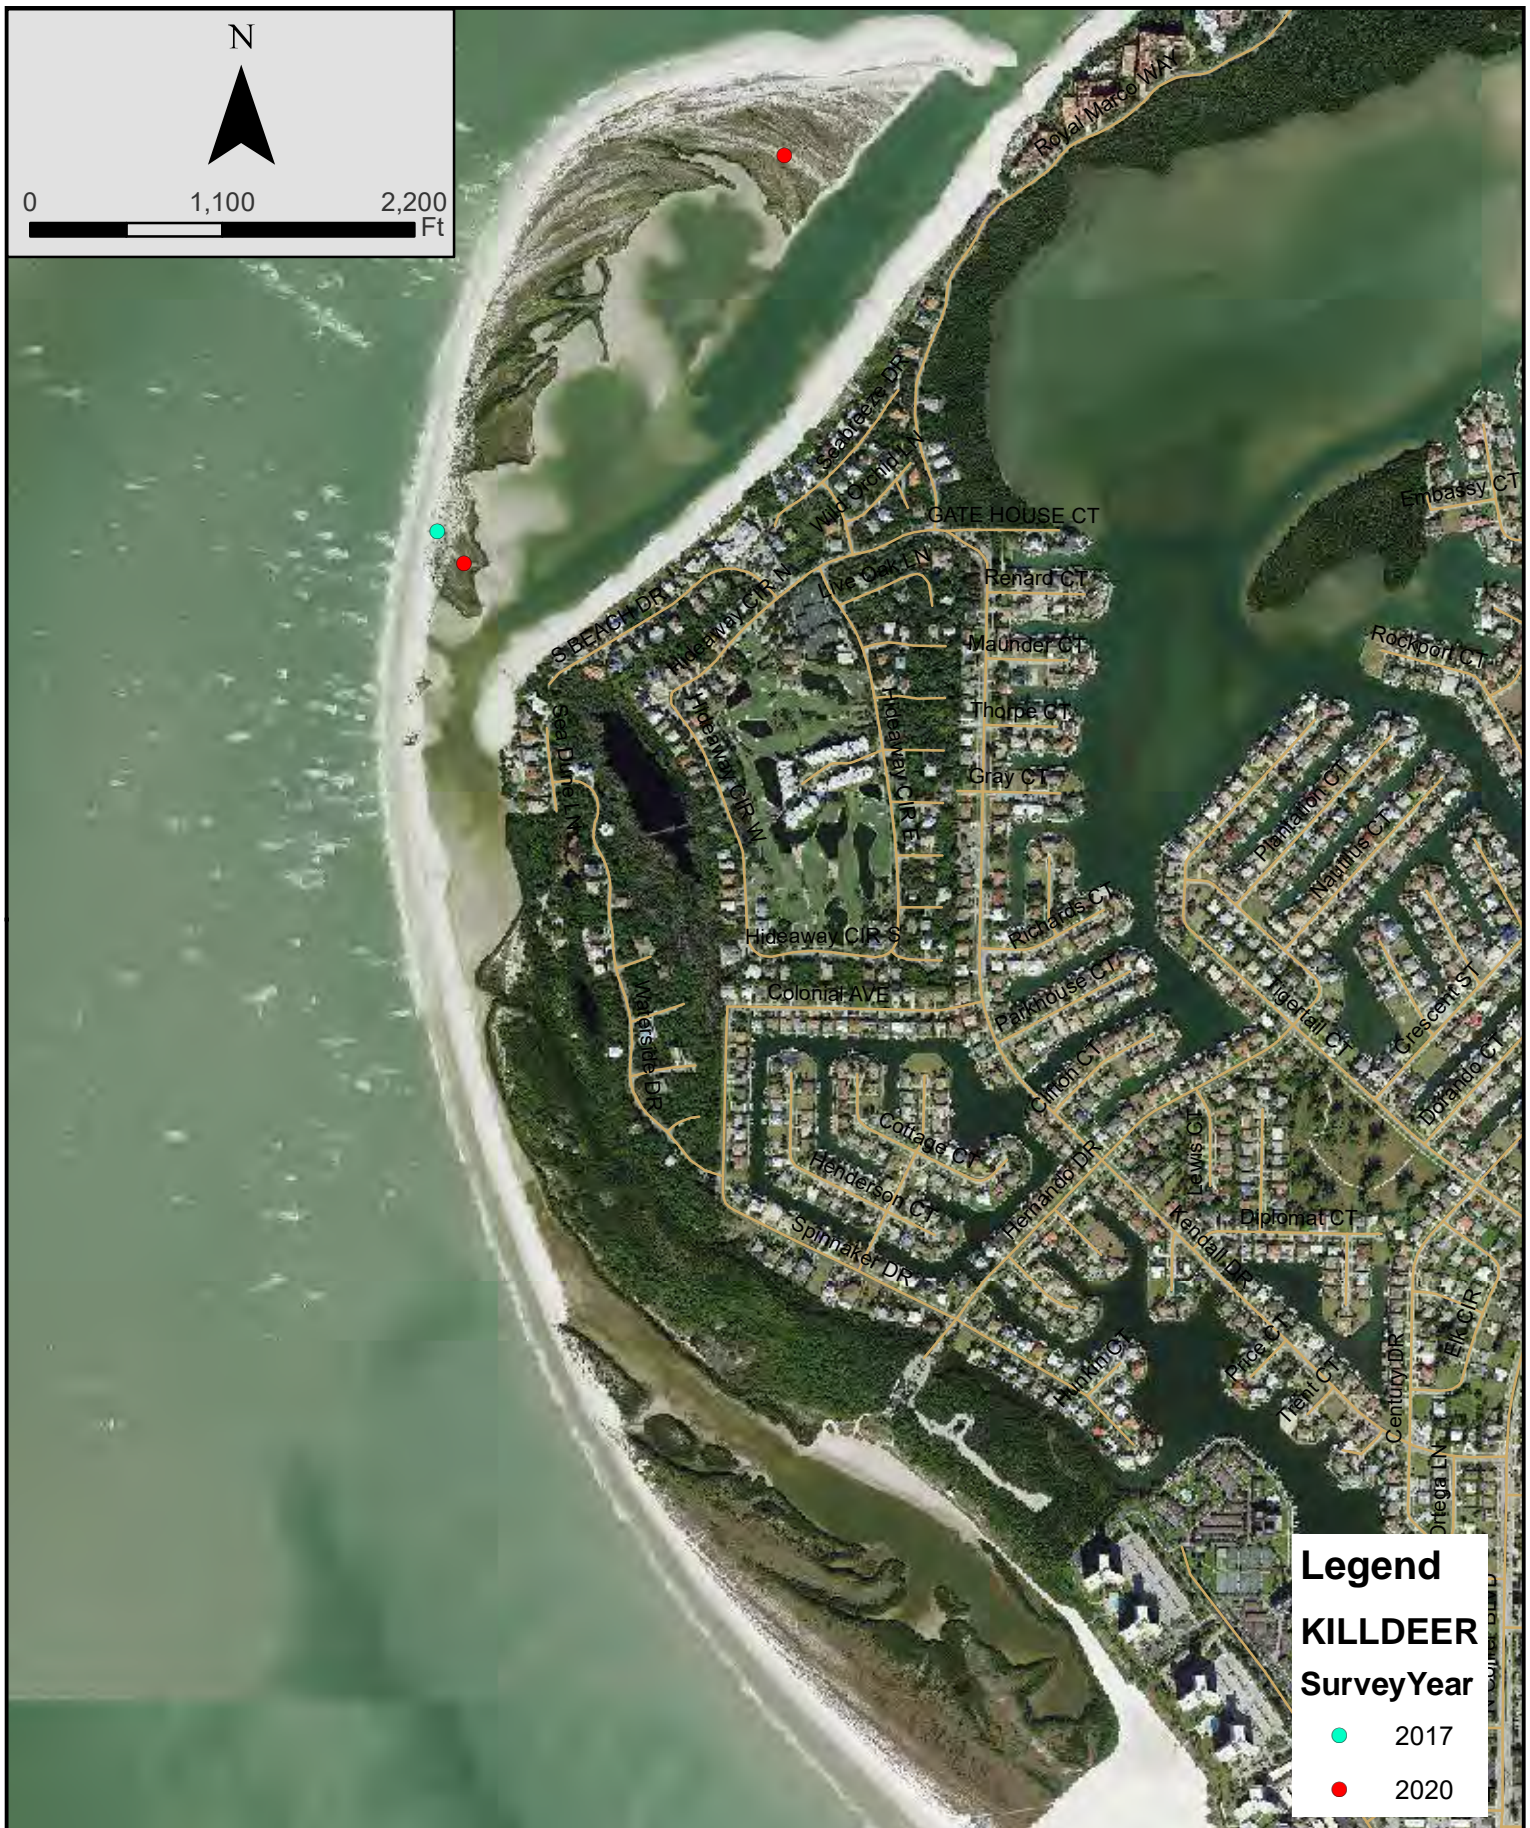
EXHIBIT 11

KILLDEER NESTS

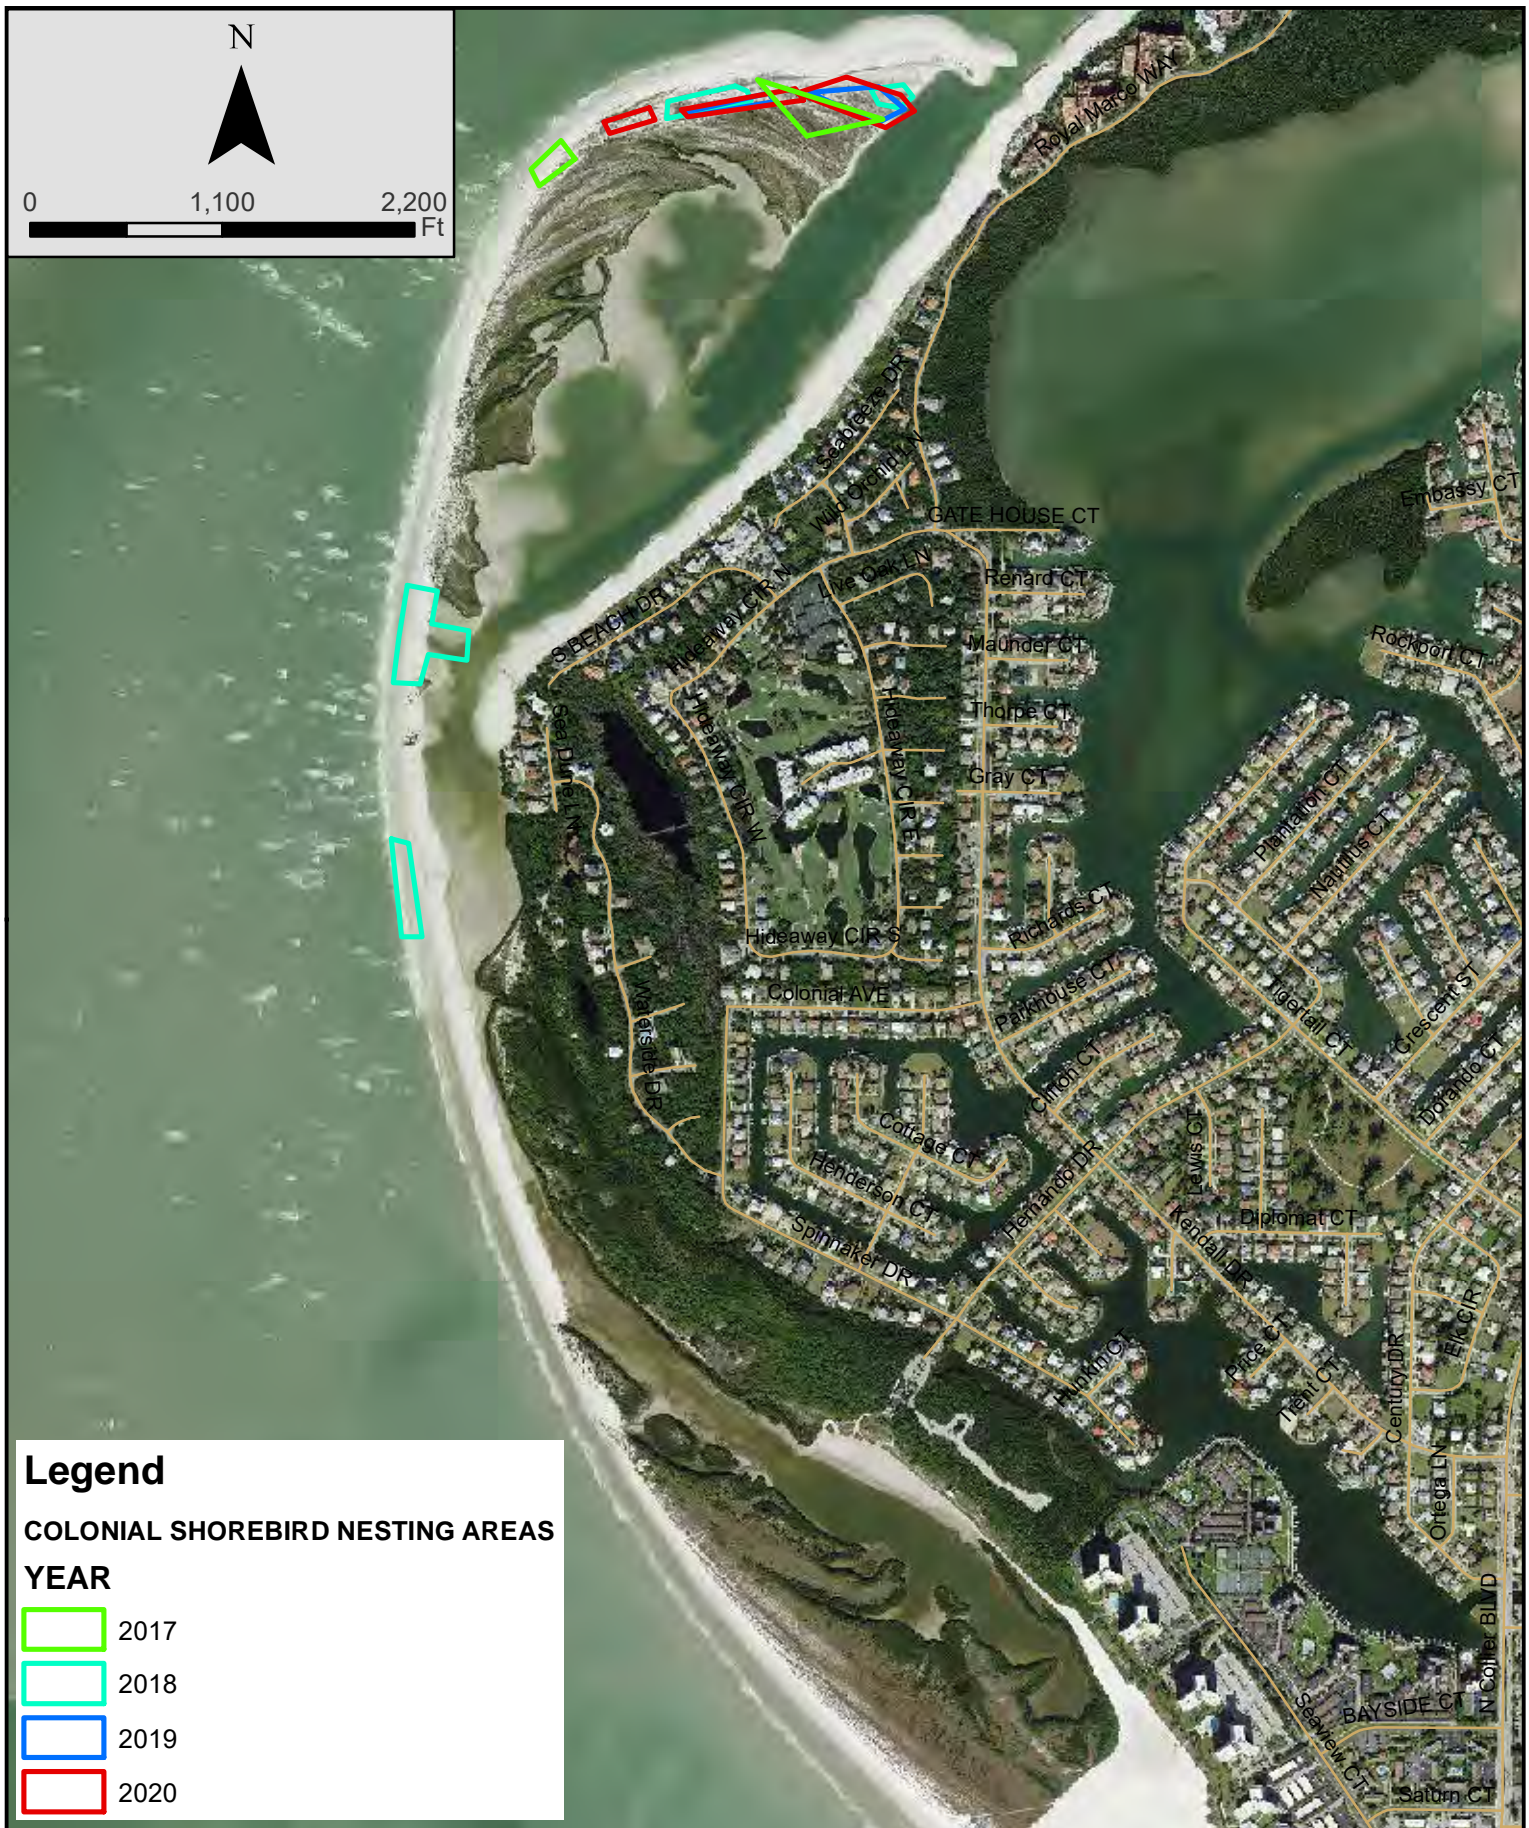
EXHIBIT 12

COLONIAL SHOREBIRD NESTING AREAS
